HEYBURN STATE PARK/ BENEWAH CAMPGROUND ROAD IMPROVEMENTS

IDAHO DEPARTMENT OF PARKS AND RECREATION

APRIL 2009

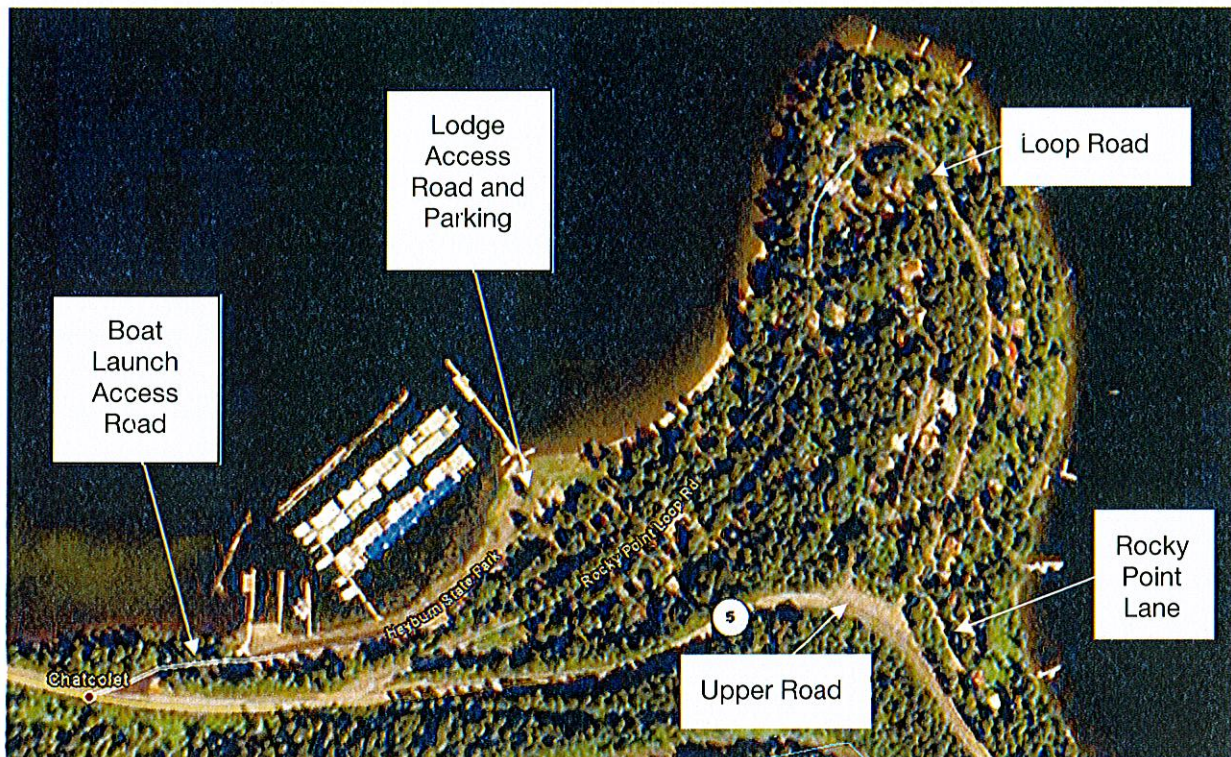
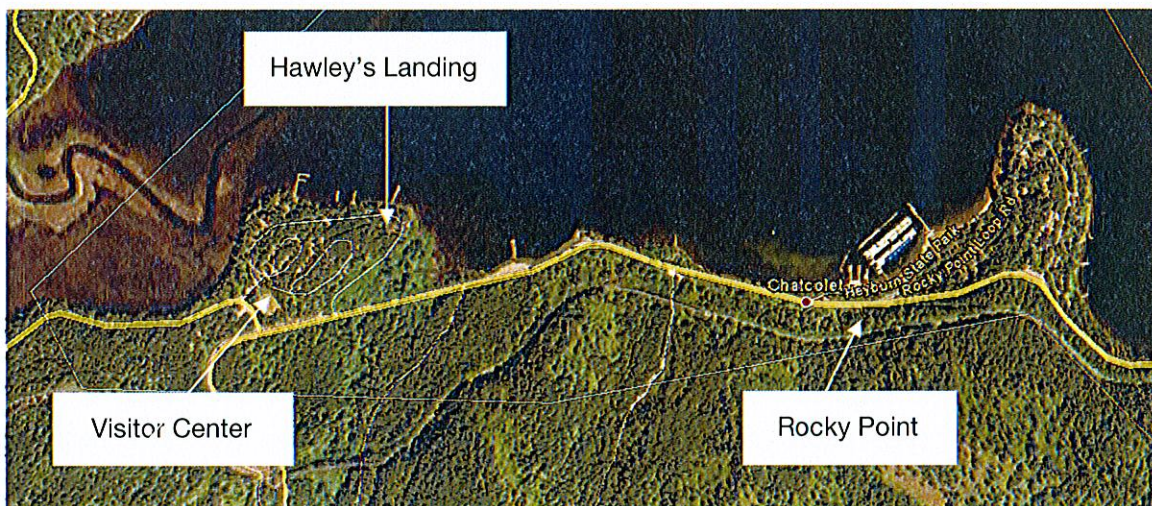
Figure 3.13: Rocky Point Overview

Roadway Name	Length of Roadway (feet)	Width of Roadway (feet)	Existing Pavement Surface	PASER Rating	Surface Pavement Conditions
Rocky Point Upper Road	792	14	Gravel	5	Road was reconstructed when the water line construction was completed.
Rocky Point Loop Road	3330	14	Gravel with patches of asphalt	2	No visible crown in the road way. Visible moderate rutting. Some potholes. Waterline was constructed in some areas.
Rock Point Lodge Access Road	580	14	Gravel	2	No visible crown in the road way. Visible moderate rutting. Some potholes.
Rock Point Lodge Parking	70	14	Gravel	2	No visible crown in the road way. Visible moderate rutting. Some potholes.
Boat Launch Access Road	1220	14	Gravel with patches of asphalt	2	Slope into boat launch area is too steep. Asphalt had deteriorated over most of the roadway.
Rocky Point Lane	375	14	Gravel	3	Good crown with slight washboarding. Isolated potholes.

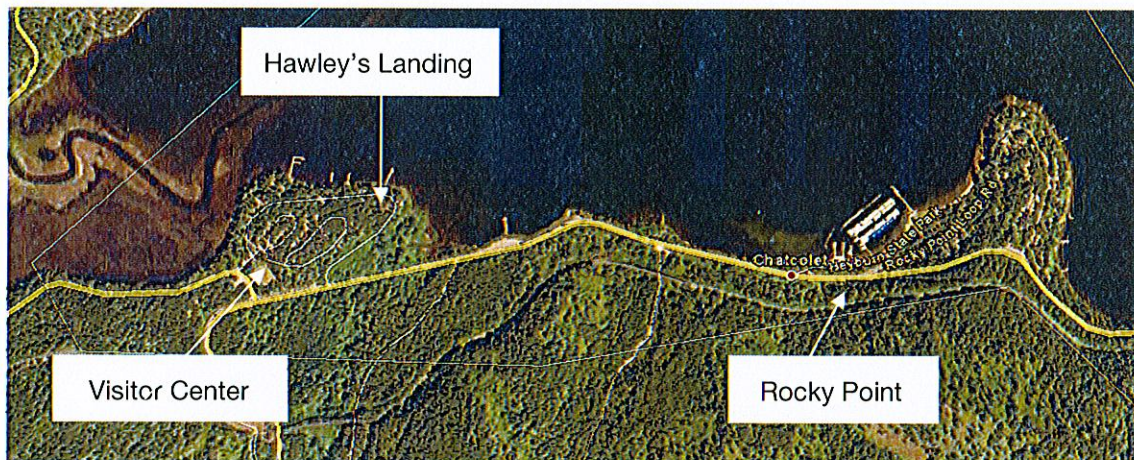
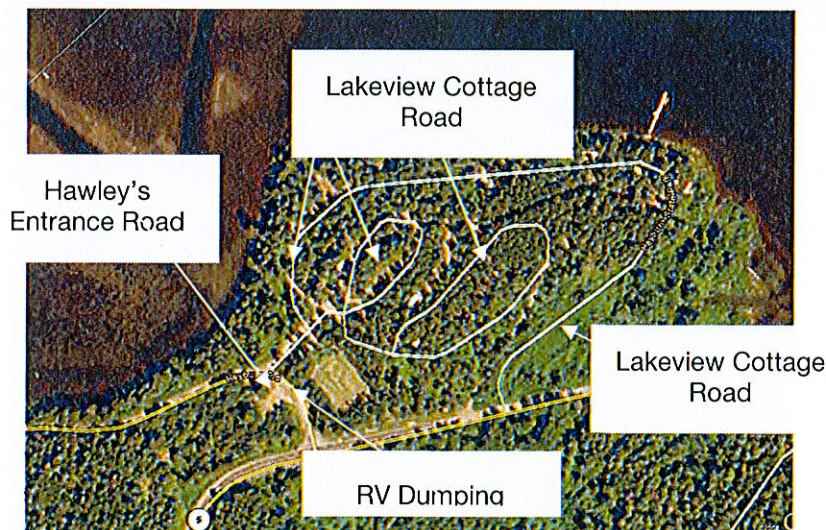
Figure 3.15: Hawley's Landing Campground Overview

Roadway Name	Length of Roadway (feet)	Width of Roadway (feet)	Existing Pavement Surface	PASER Rating	Surface Pavement Conditions
Entrance Road	500	14	Asphalt	8	No visible surface cracks or potholes.
RV Dumping Station	200	14	Gravel	3	Minor rutting and potholes.
Campground Roads	845	14	Gravel	4	Some regrading required for drainage. No visible rutting or potholes.
Lakeview Cottage Road	1005	12	Gravel	3	Some potholes, rutting, no dust control, regrading required for drainage.

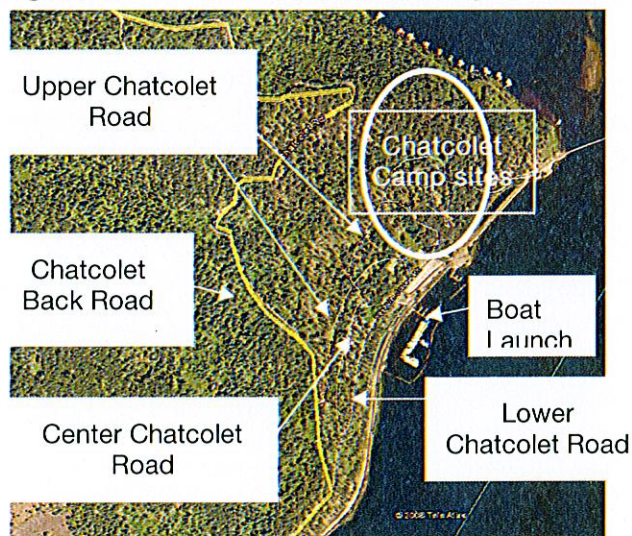
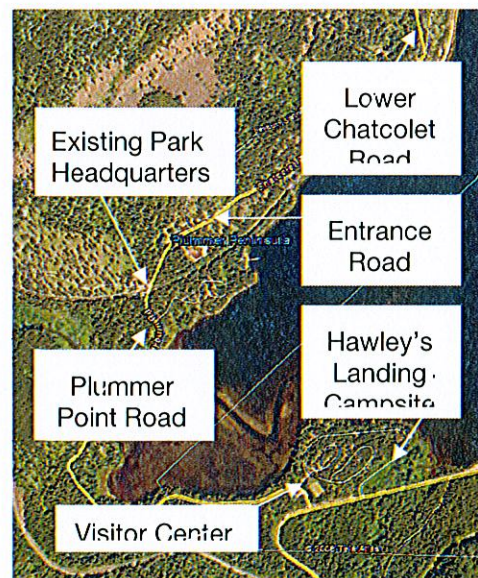
Figure 3.18: Chatcolet Roadway Overview

Roadway Name	Length of Roadway (feet)	Width of Roadway (feet)	Existing Pavement Surface	PASER Rating	Surface Pavement Conditions
Entrance Road (not including Visitor Center area)	10,560	20	Asphalt	8	Pavement striping is worn, slight raveling of surface material in some areas, dark areas indicated that asphalt has worked to the surface.
Visitor Center Area	Unknown	20	Asphalt	10	Newly constructed
Center Road	1220	14	Gravel	3	Reconstructed when the water line was placed.
Upper Road	5125	20	Gravel	3	Some rutting and washboarding are visible.
Lower Road	3300	20	Asphalt	8 and becomes 2 after boat launch	Boat launch to Chatcolet Road asphalt shows little wear. From the boat launch to the campground road asphalt has deteriorated.
Back Road	7,920	20	Asphalt	7	Very slight raveling, surface shows some traffic wear.
Campground	2,420	14	Gravel	3	Some rutting and washboarding are visible.
